Caterham-on-the-Hill

Surface Water Management Study

Surrey County Council

April 2016

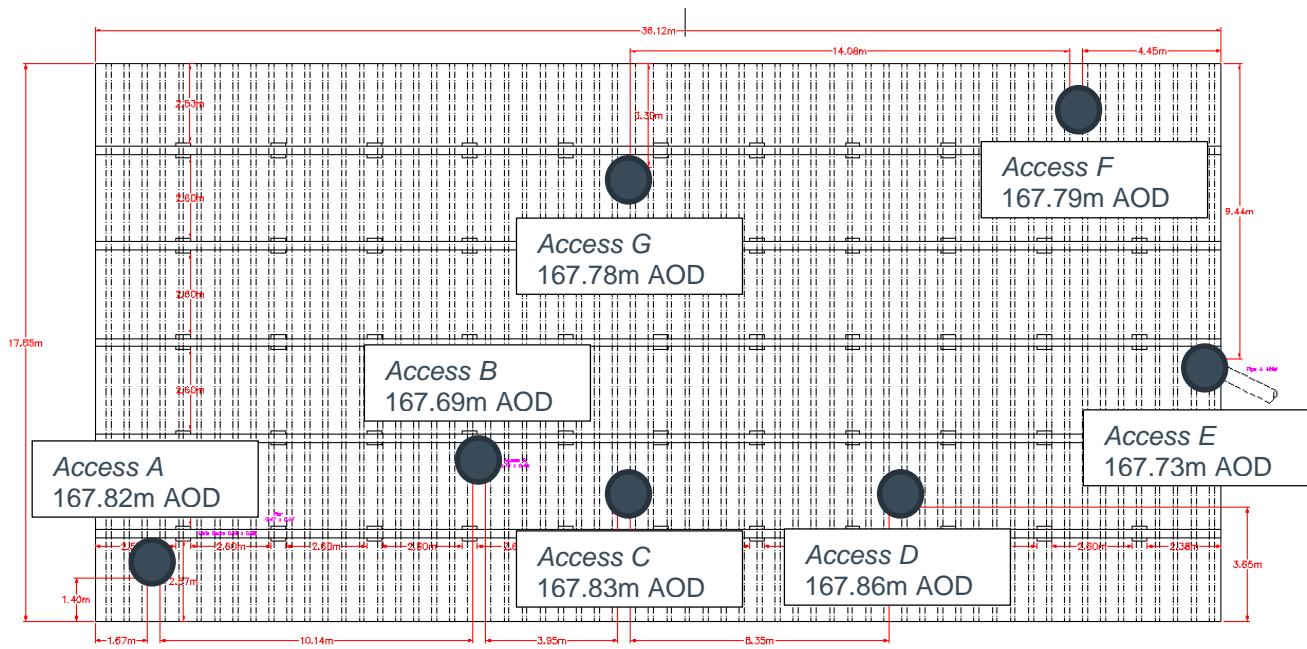
Figure 2-1 Plan view of the Money Pit showing access locations and levels

There are seven inspection covers at random intervals in the slab. There are no means of entering (such as ladders or step-irons) to allow persons to enter the chamber from these access covers. Figure 2-1 illustrates the location of the inspection covers and the surveyed cover level.

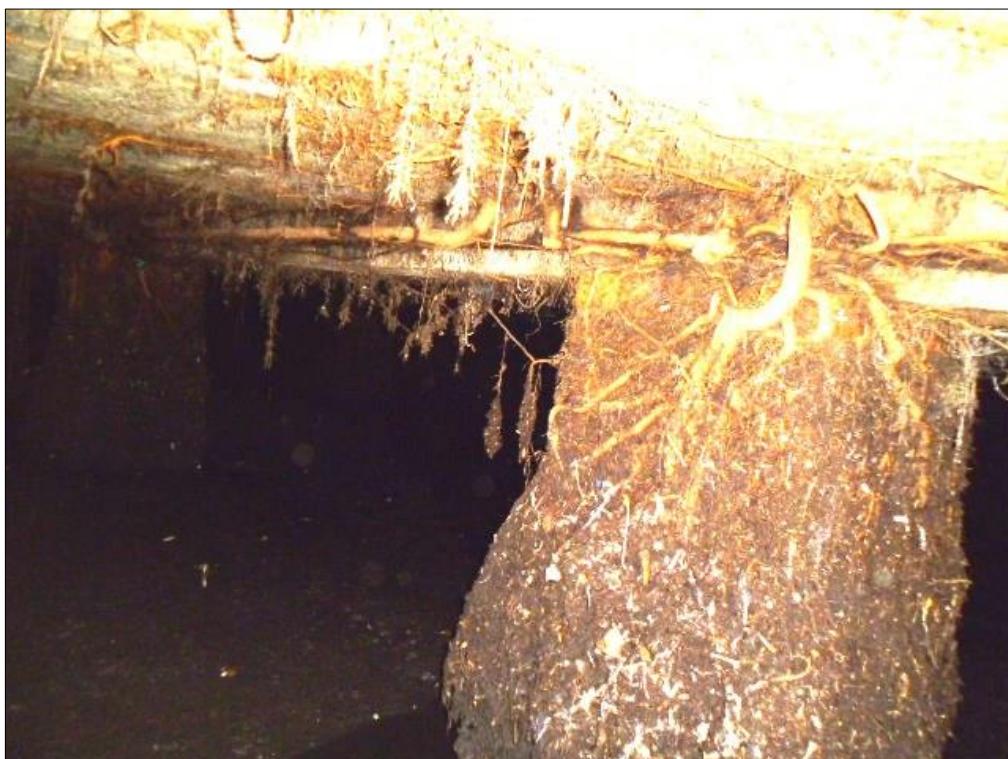
Access covers were found to be rusted, although not to a dangerous state. At the time of the survey, approximately 80% of the slab over the Money Pit was covered with vegetation, including brambles and small shrubs and trees. Soil and roots had to be cleared to access the covers. The vegetation growth meant that the survey team was unable to assess the condition of the slab surface. There was evidence of root ingress into the chamber from the slab above, as illustrated in Figure 2-2. The chamber wall and brick piers all seemed structurally sound with no evidence of cracking or displaced brickwork. The mortar joints seemed in good condition.

Figure 2-2 Root ingress through the Money Pit slab and onto one of the chamber's piers

It is recommended that the surface slab is cleared of all vegetation and the roots treated to avoid further ingress into the chamber. Also suggested would be to clear silt at the base of the chamber to open up any pipes that may be entering or leaving.

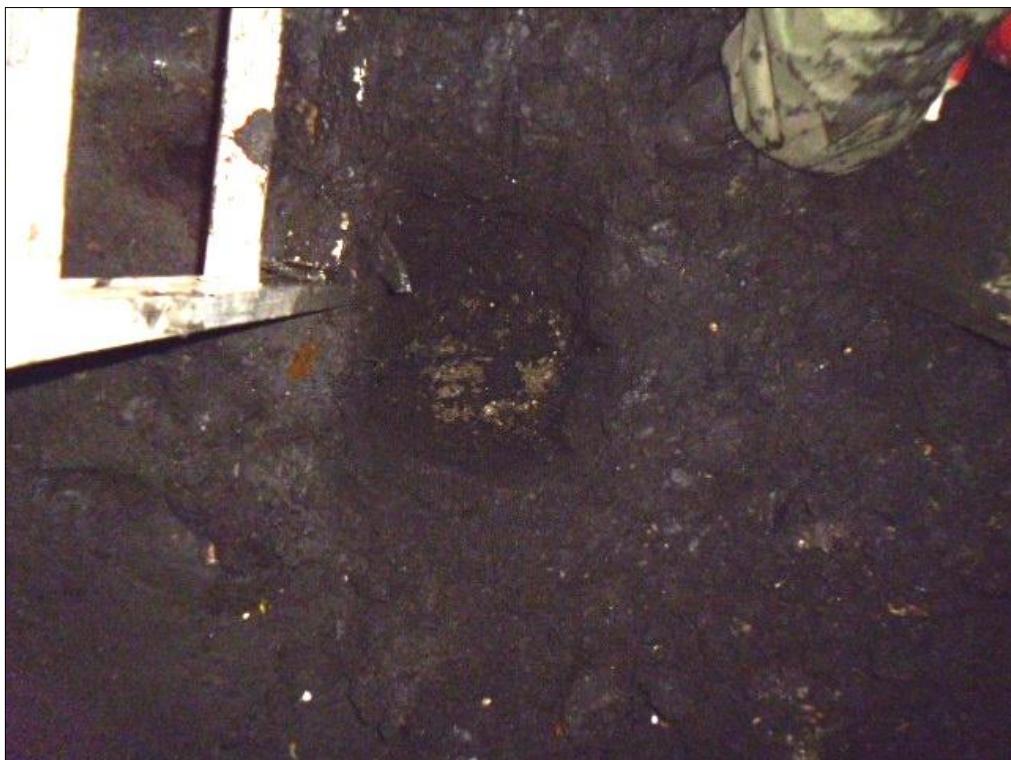
There was an average of 400mm of silt at the base of the Money Pit (see Figure 2-3), though in some areas this was considerably more, particularly in the northern corner of the asset where silt was seen to be piled up against the chamber wall (see Figure 2-4). Due to the levels of siltation, the survey team were unable to leave the base of the inspection chamber area to assess the wider condition of the asset.

Figure 2-3 Silt levels at base area of access cover D

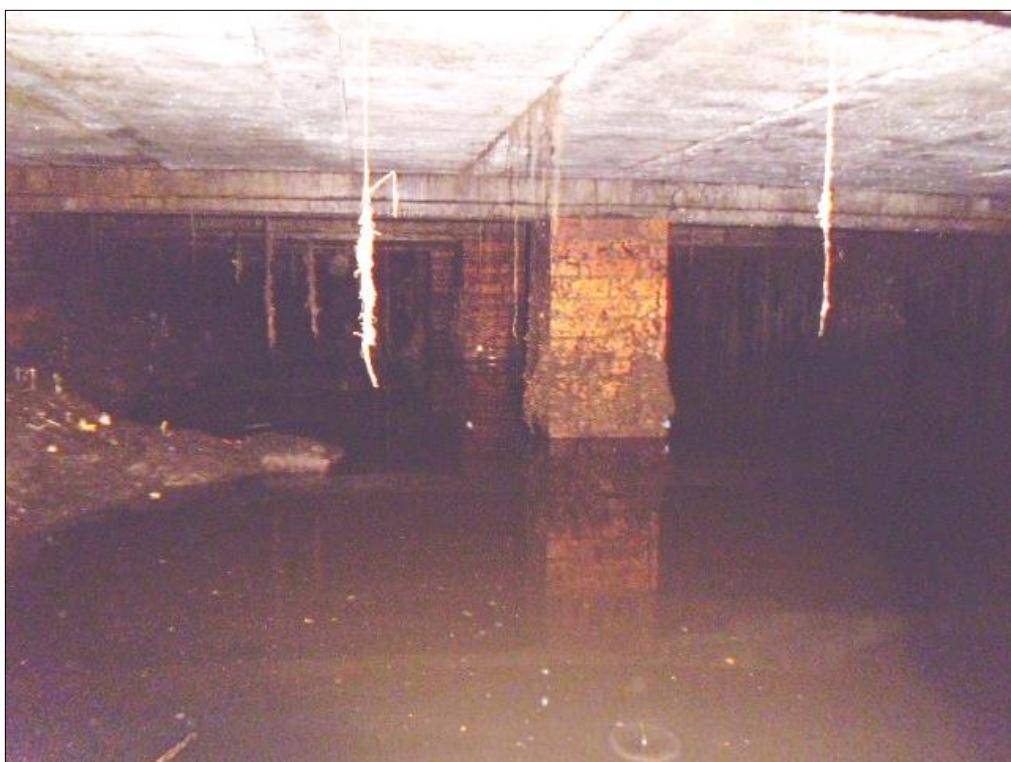
Figure 2-4 Photo from Access A showing area of considerable sedimentation and standing water

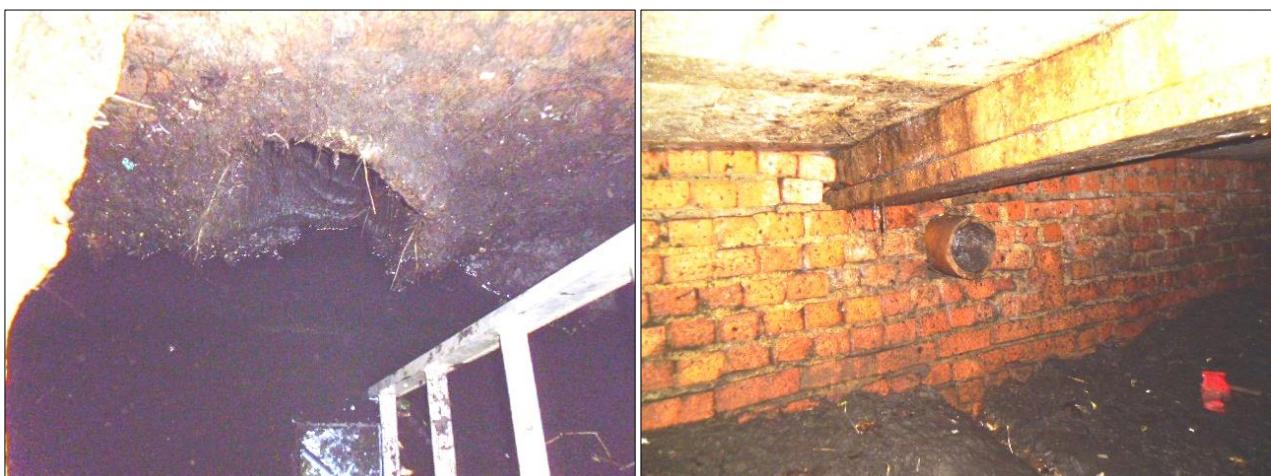
- A mid-level (0.4m from base) 450mm conduit with an invert level of 166.5m AOD along the south-eastern side of the chamber, close to Access E (see Figure 2-5 and 2-6); and
- A high-level (1m from base) 150mm conduit with an invert level of 167.1m AOD along the north-western of the chamber, close to Access A (Figure 2-5).

The mid-level 450mm incoming conduit is the main storm drain. The high-level 150mm incoming conduit is believed to be a private connection.

Figure 2-5 Money Pit incoming pipes (450mm on left and 150mm on right)

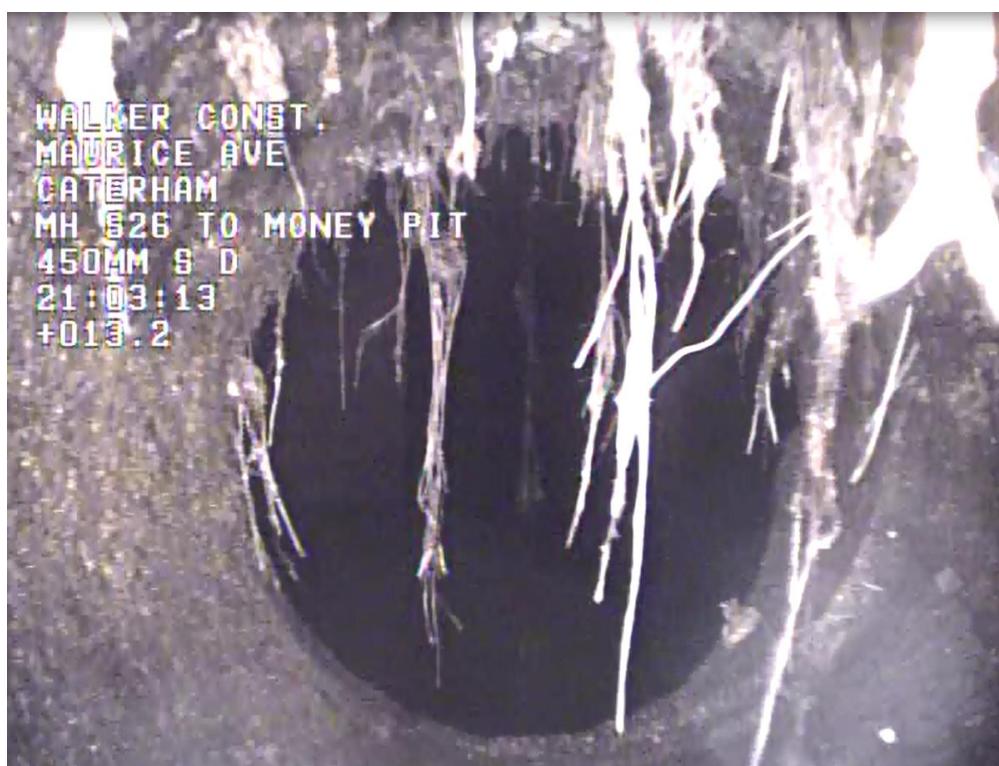
Figure 2-6 2013 CCTV survey of 450mm pipe outfalling into the Money Pit chamber

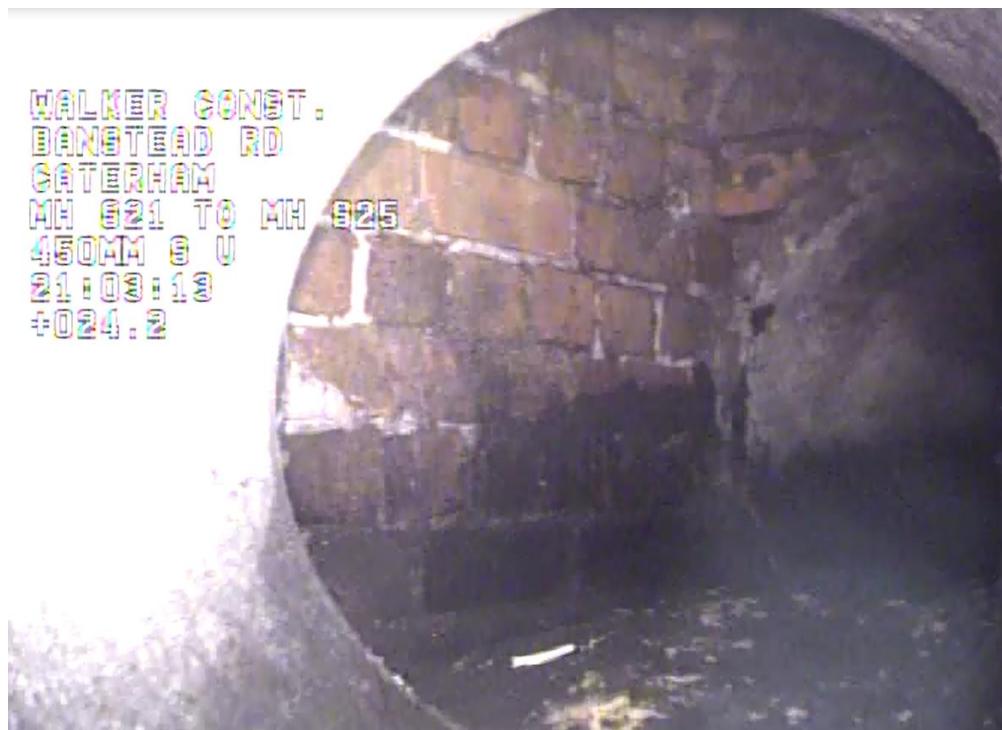
A previous CCTV survey (AB Pipeline Services Limited, March 2013) surveyed a length of sewer on the main storm drain just downstream of the Money Pit. The upstream end of the survey was a manhole chamber in the garden of 99 / 101 Banstead Road, to the north-west of the Money Pit. Looking upstream, the 2013 CCTV survey image (see Figure 2-8) clearly shows a large conduit (approximately 450mm) running from the manhole chamber in the road, towards the Money Pit. Access to this manhole chamber was not available and hence it was not possible to confirm connectivity.

Figure 2-8 2013 CCTV survey showing manhole downstream of The Money Pit

Although there is no direct evidence of an outgoing connection from the Money Pit chamber, the available evidence, including the 450mm diameter conduit found in the 2013 CCTV survey, suggests that there is an outgoing conduit from the Money Pit which is part of the main storm drain and can convey flows downstream. The invert of this conduit connection is unknown.

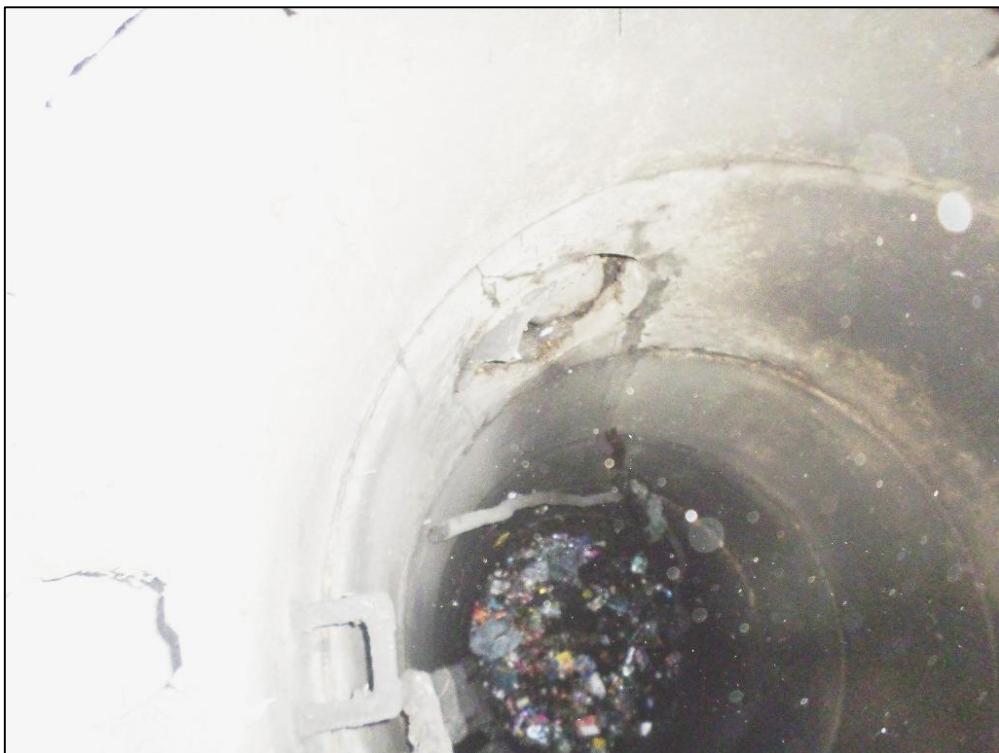
The slab is covered with vegetation. The cover and frame were found to be rusted although not to a dangerous state. The chamber rings and slab appeared to be structurally sound with no evidence of cracking or spalling. The base of the chamber is heavily silted with approximately 150mm of sediment and trash, including plastic drinks bottles, crisp packets and plastic bags. This is illustrated in the photograph in Figure 2-9.

Figure 2-9 Image into soakaway chamber showing trash covering the base

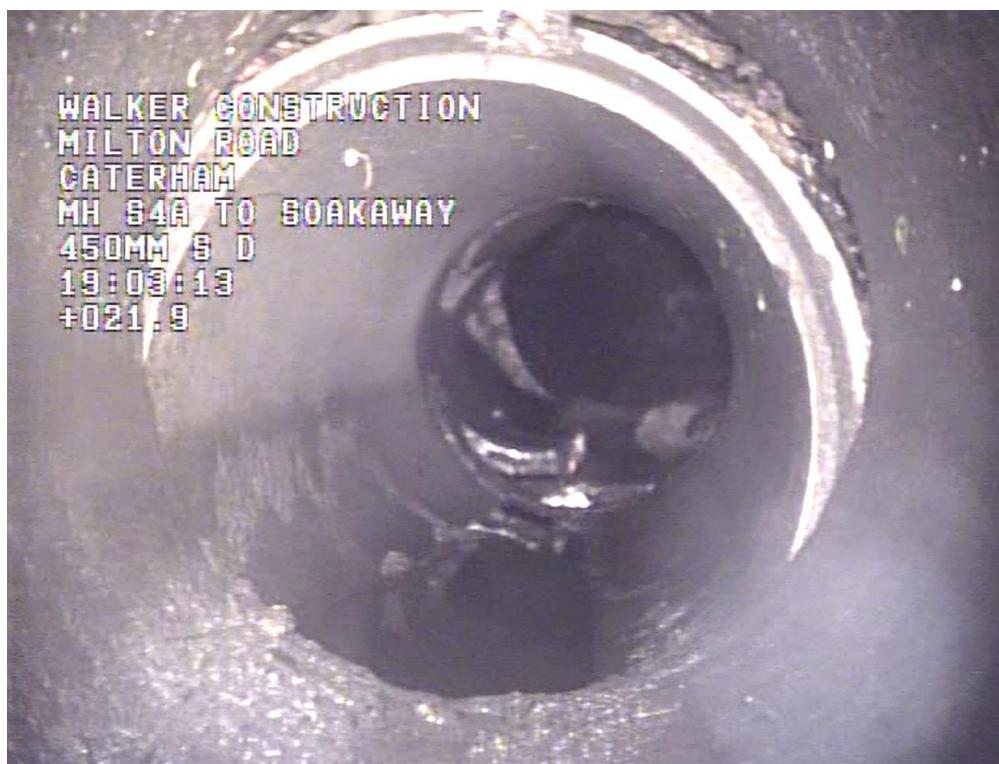
There is a single incoming circular concrete culvert with a diameter of 450mm and an invert level of 150.11m AOD. This is the main storm drain. The CCTV survey (AB Pipeline Services Limited, March 2013) found this pipe to be fractured and deformed, as illustrated on Figure 2-10. No other pipes were located in the chamber, and hence with soakaway has no formal overflow mechanism.

Figure 2-10 2013 CCTV survey showing fractured and deformed pipe, ending in the soakaway

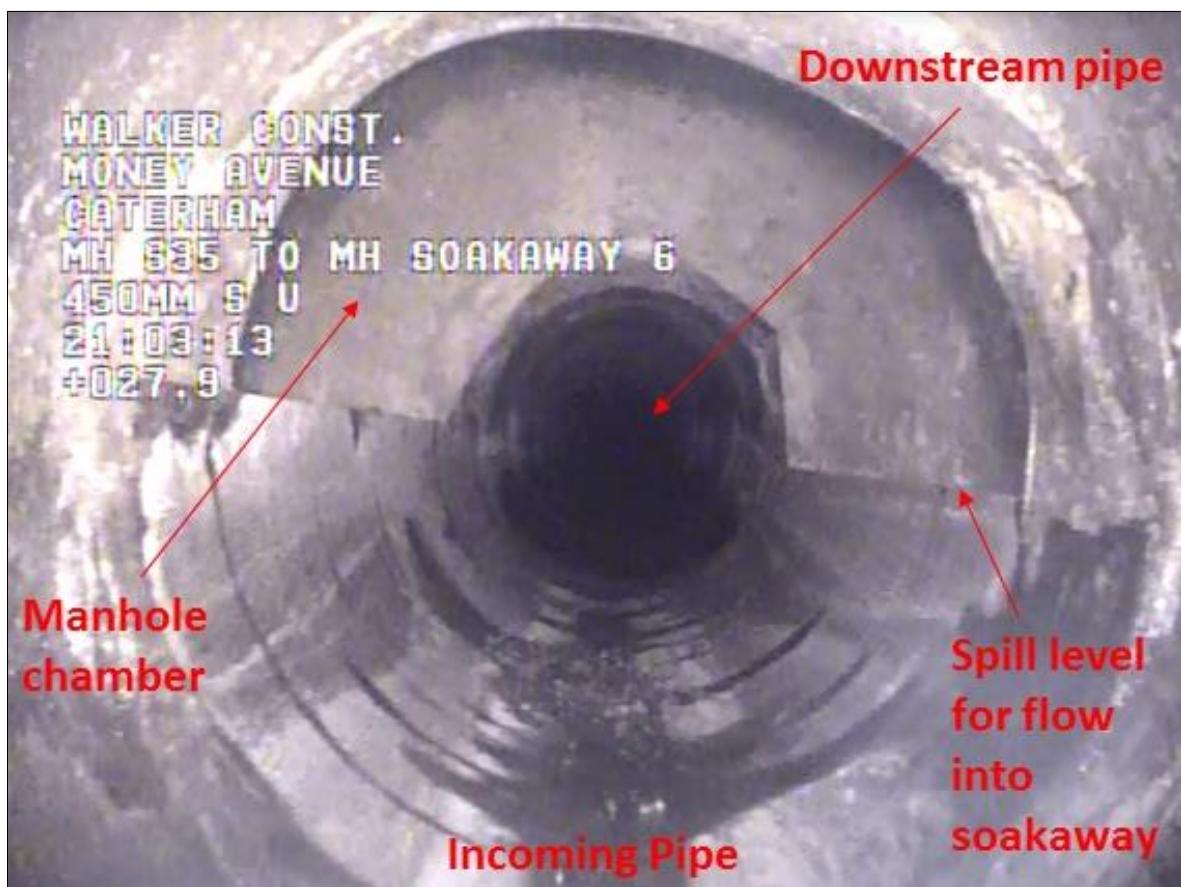
Figure B-1 CCTV photo of soakaway 2 (Money Avenue)

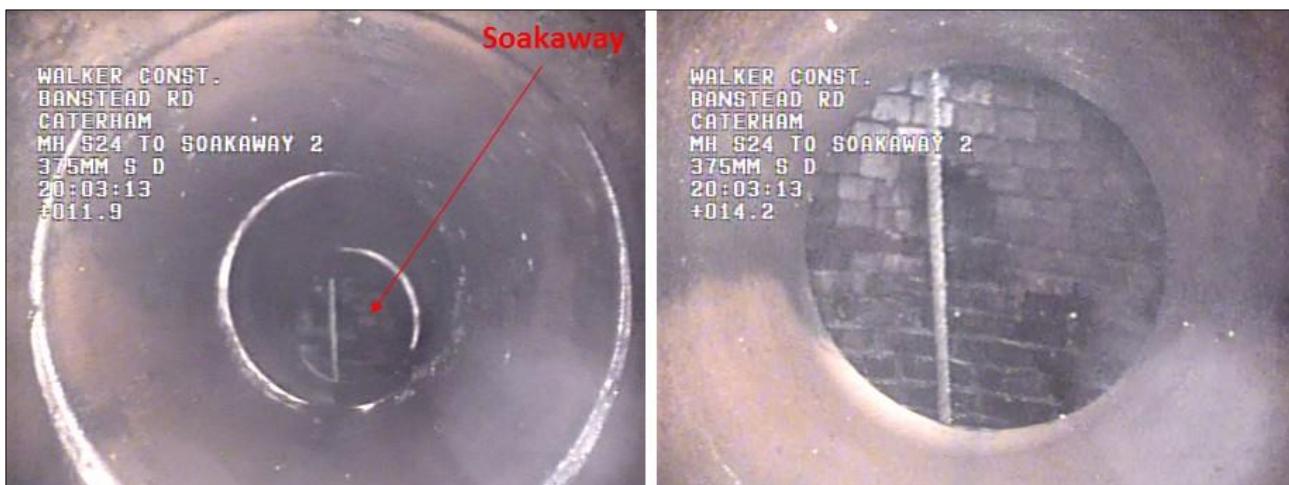
Figure B-2 CCTV photo of soakaway 3 (Junction of Campbell Road and Banstead Road)

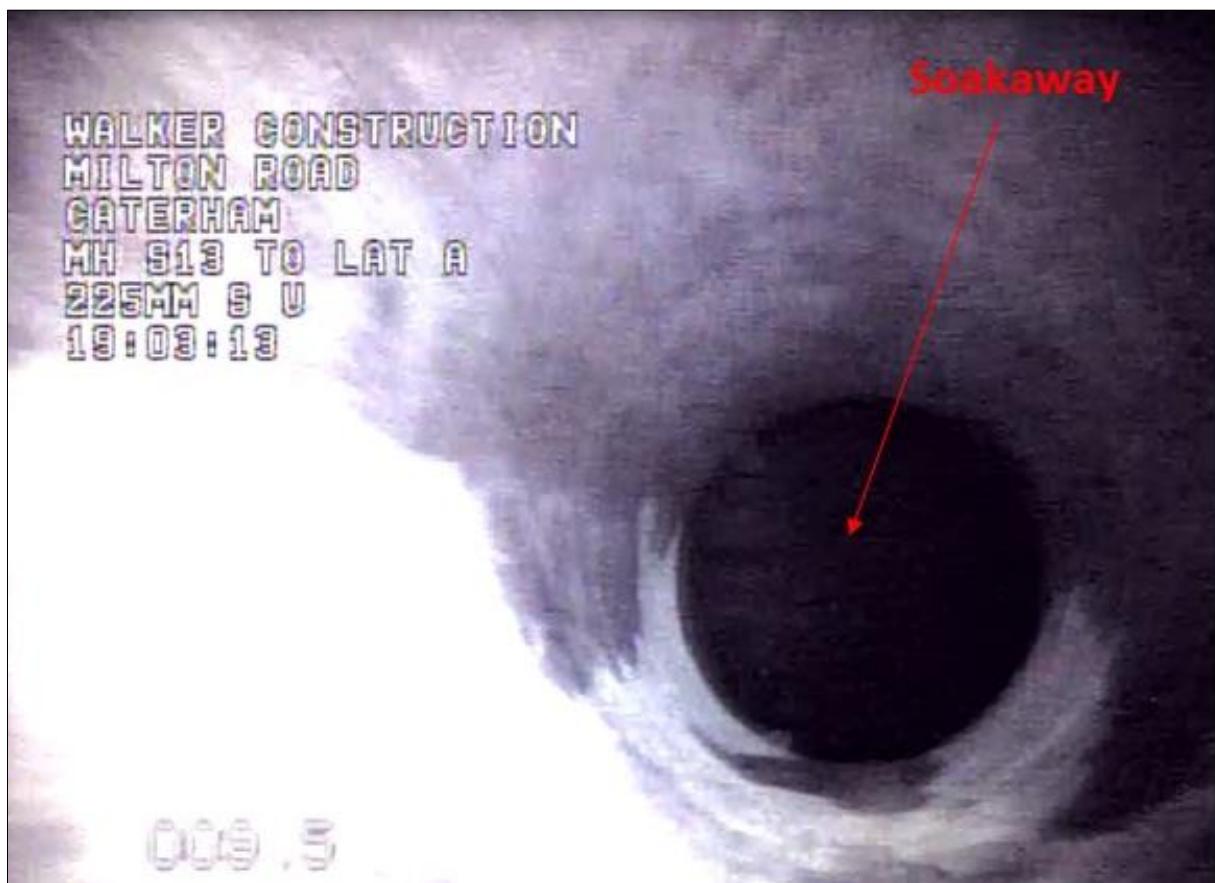
Figure B-3 CCTV photo of soakaway 4 (Junction of Milton Road and Banstead Road)
