Caterham-on-the-Hill

Surface Water Management Study

Surrey County Council

April 2016

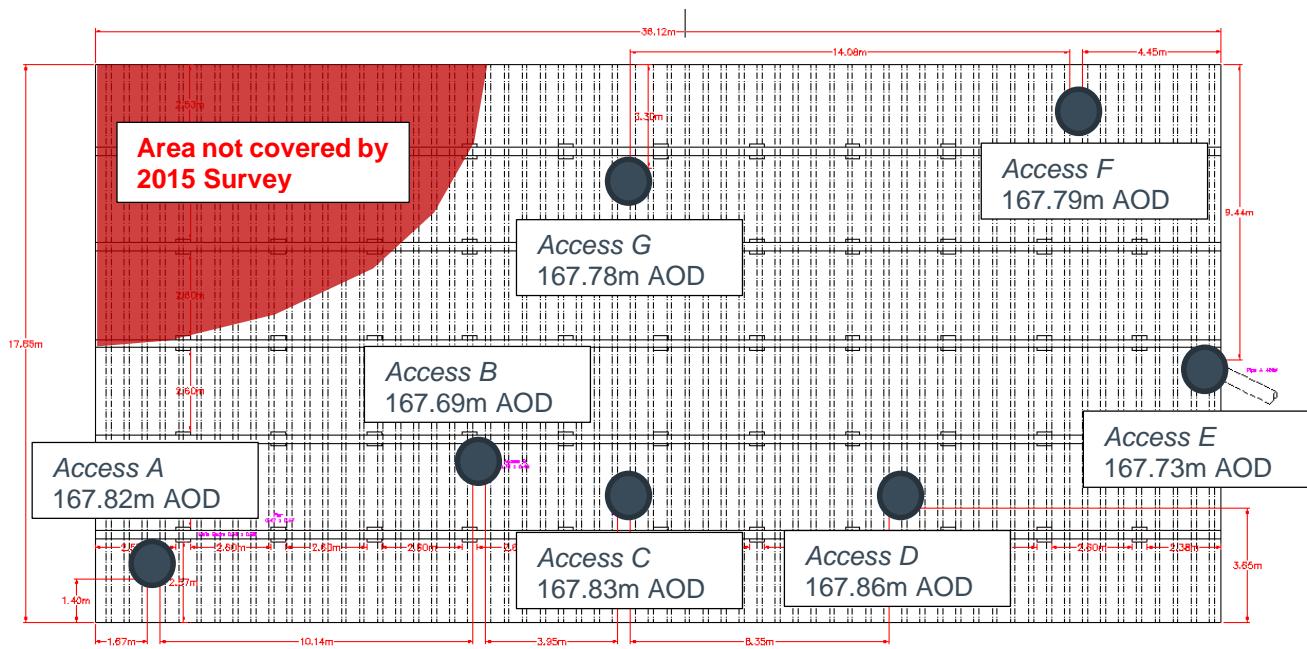
Figure 2-7 Coverage of the 2015 Money Pit survey

No outgoing connections were found. Since the surveyors were only able to survey the area immediately surrounding the base of the access chambers, there is a possibility that an outgoing connection is present in the northern corner of the asset which was not covered in the survey, as shown in Figure 2-7. It is also noted that any low-level incoming or outgoing pipes could not have been observed because they would have been buried beneath the 400mm of silt.

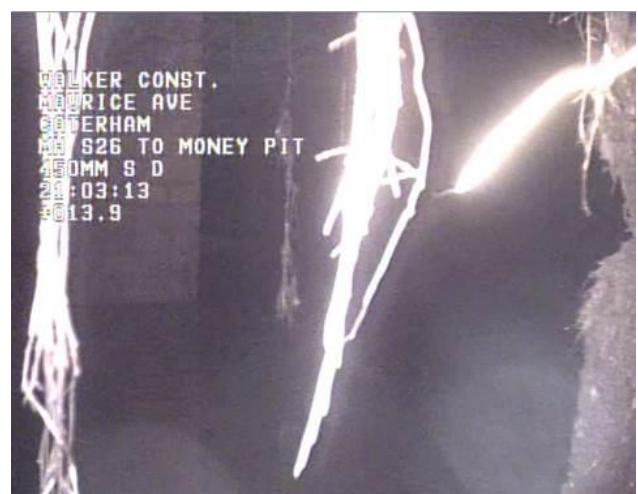
CCTV survey (2013) – image from the surface water pipe looking downstream into the Money Pit.

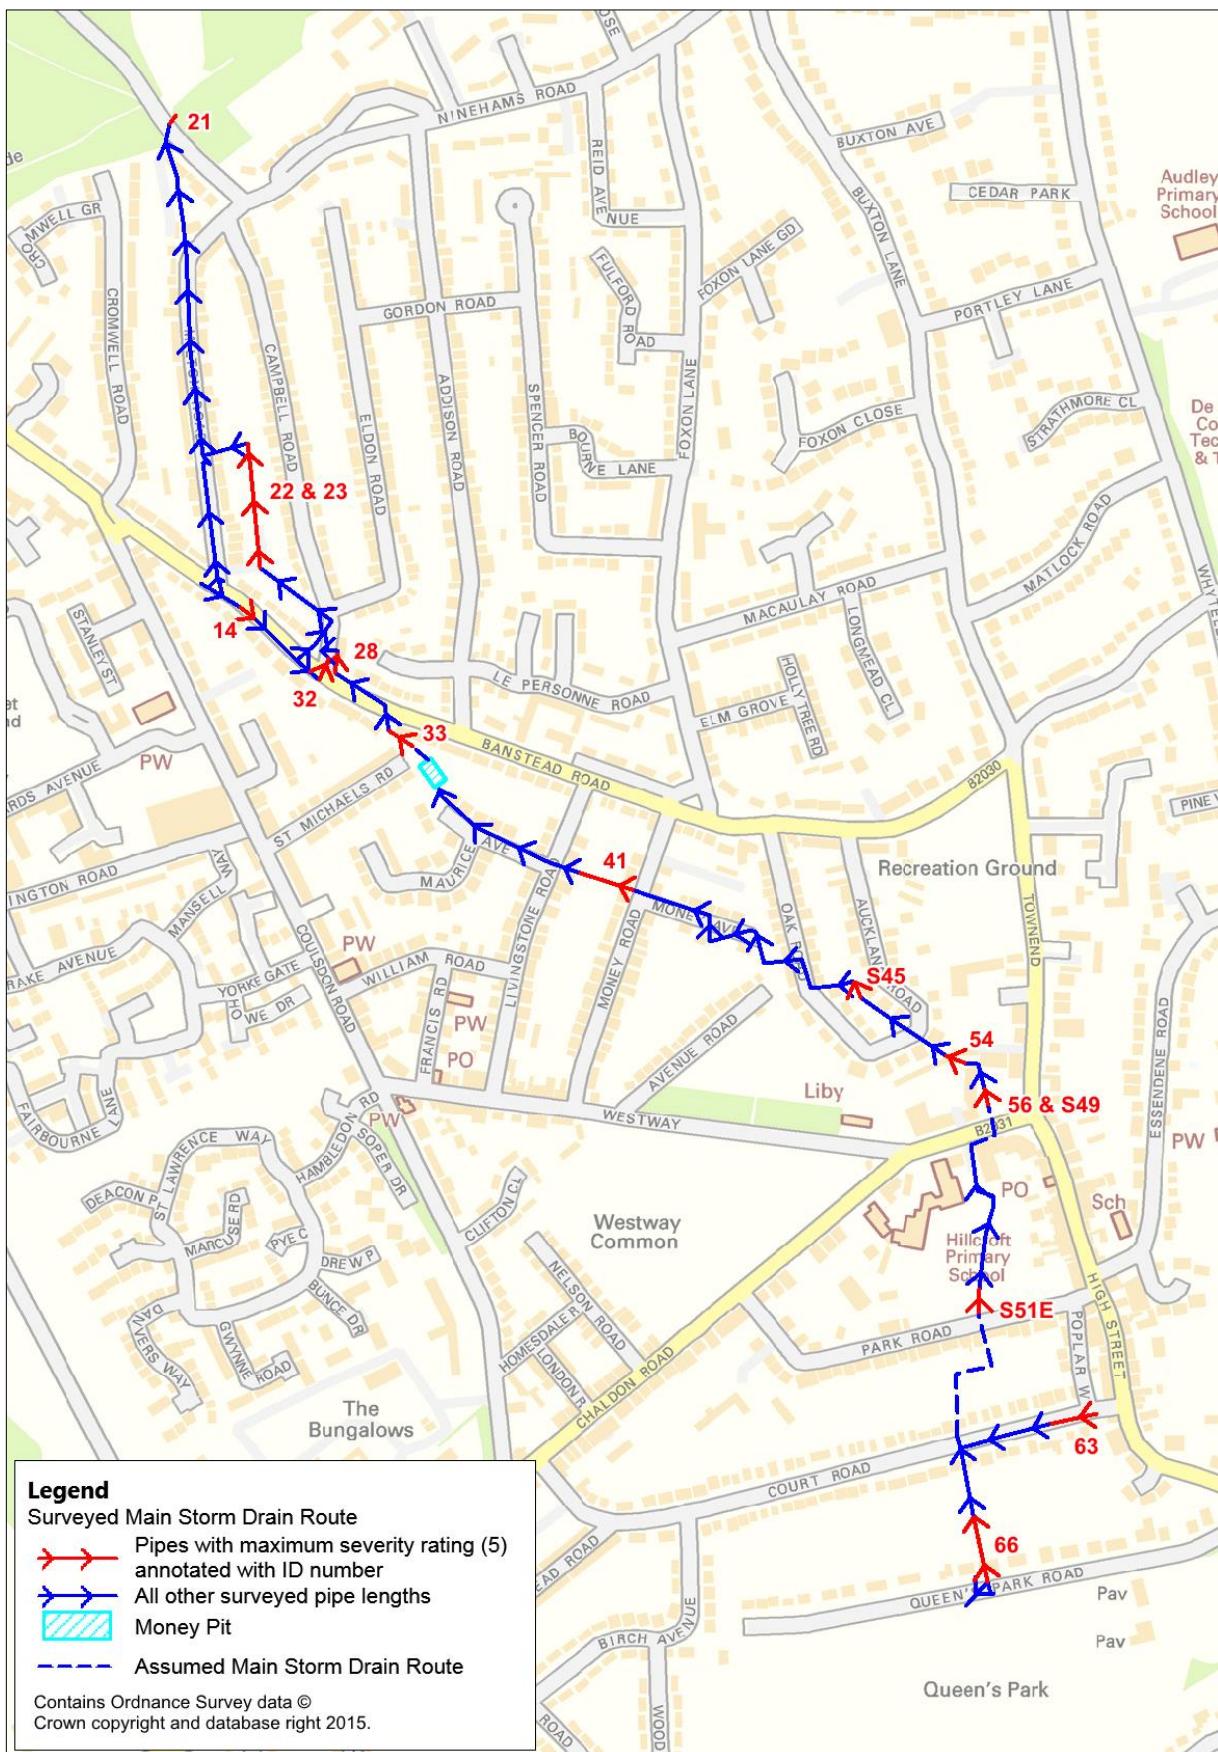
Figure B-4 Map of CCTV-surveyed pipe lengths

A summary table containing information about all 68 surveyed pipe lengths is available in Appendix B. The ID column within this table relates to the pipe locations as illustrated on the map in Appendix B. A summary of the pipe lengths that were allocated the maximum severity score are shown in Table 2-2. Of significant interest are pipe lengths 63 and 66, both of which are located in between Queens Park Road and Court Road, an area that is known to flood (see Section 3). These pipes are in a poor condition, with cracks and roots, and two collapsed sections. There are reported blockages of up to 50% in what are relatively small pipes (150mm in

Also of interest is the pipe just downstream of Money Avenue (no. 41). Money Avenue is also an area highlighted by SCC as an area that has experienced flooding, verified by the SCC Wetspots and the Environment Agency uFMfSW. Pipe 41 has also been allocated the highest severity ranking, which in this location relates to cracks and siltation.

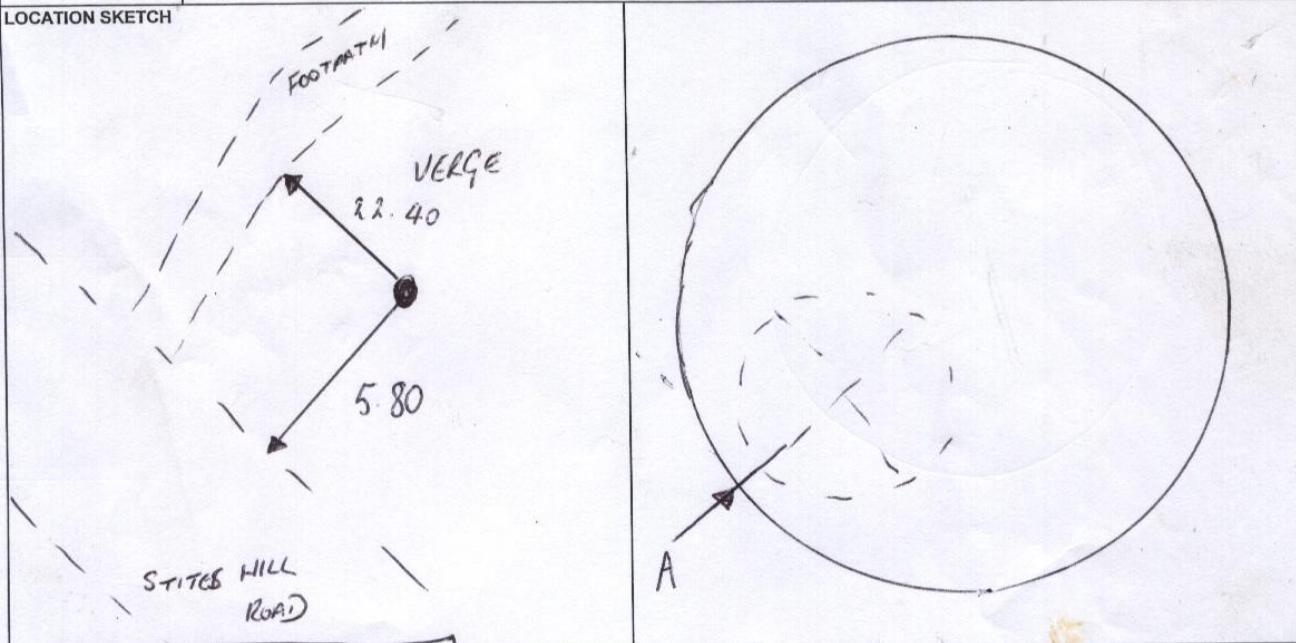
Stites Hill Soakaway

REMARKS	* THIS IS A SOAKAWAY HOLE'S IN CHAMBER WALL. UNABLE TO Probe through SIGHT TOP OF SIGHT DCPTH TO 6.05m SURcharge of 0.65 m.
---------	---

It is recommended that the surface slab is cleared of all vegetation and the roots treated to avoid further ingress into the chamber. Also suggested would be to clear silt at the base of the chamber to open up any pipes that may be entering or leaving.
